# Manhole Inspection Summary

Manhole # S45MM\_006MH

**Inspection** ☐ Is Incomplete Rating: **3) Fair**

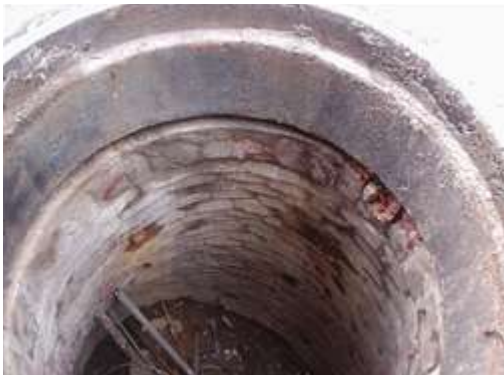
Defect 2

**Frame** Offset: **0** (in.) Condition: ☐ Sound ☐ Cracked ☒ **Leaks**

Frame leaks

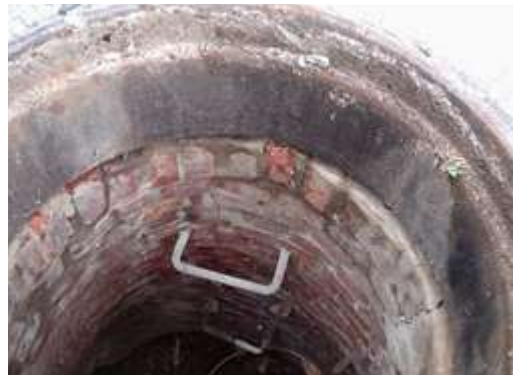
Defect 1

Condition: ☐ Sound ☐ Cracked ☐ Root Intrusion ☒ **Loose Brick** ☐ Deteriorated

loose bricks

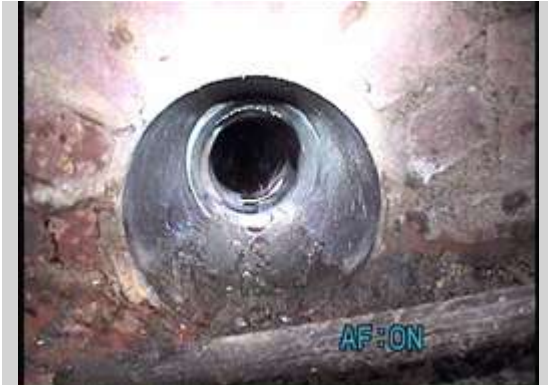
12 O'Clock Outflow

8 in. Circular Gravity Sewer  
Pipe Out @ 12 O'Clock

Infiltration: **None** Pipe Seal Cond: **Sound**
